**PHASE I / II ENVIRONMENTAL SITE ASSESSMENT
(BASELINE ASSESSMENT)**

CN RAIL LINE AND DALHOUSIE PORT,
DALHOUSIE, NEW BRUNSWICK
(PID#s 50234251 & 50352038)

November 2024

Project No: 17712

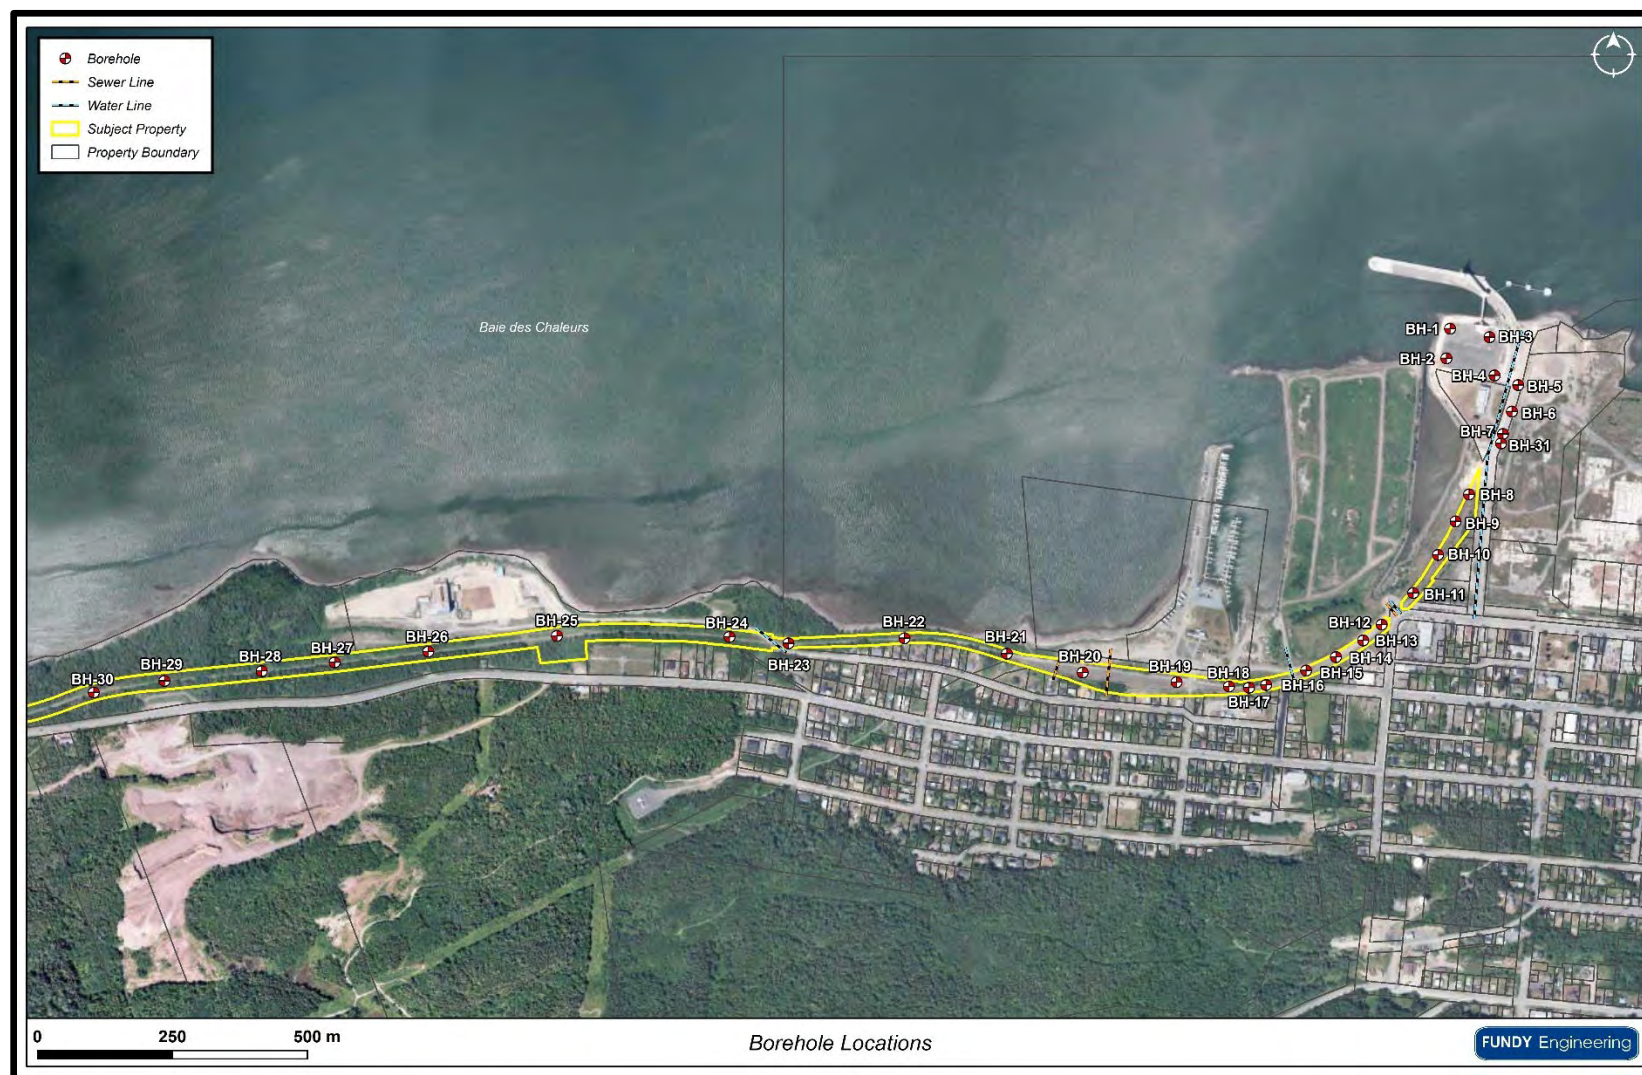
Figure 3. Borehole / Monitoring Well Location Plan.

The rationale for the borehole and monitoring well locations was to place the boreholes / monitoring wells down-gradient or in as close proximity as possible to areas of concern without damaging the underground and aerial utility lines. The borehole / monitoring well location plan is provided below on Figure 2.
